**Flood Control Project Maintenance
Levee Inspections**
LMA District Cover Sheet
Spring 2019 Levee Inspection Results

Sutter Maintenance Yard Nelson Bend

Waterway			Bank	Unit Miles
Unit No. 01 Feather River West Levee - Nelson Bend				0.50
	Spring (March - May)	Summer (June - August)	(September - November) Fall	Winter (December - February)
Unit Maintenance Rating (Fall Only)				
Date of Inspection	4/24/2019 - 4/24/2019			
DWR Inspector	Sterling York			
Accompanied By	Steve Beckley

Levee Inspection Report By Mile - Spring 2019

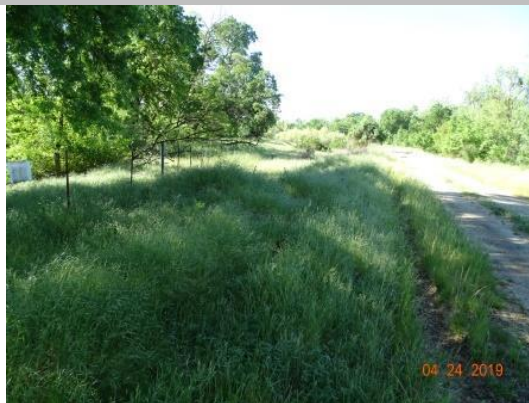
Photo 1 of 1 : SP_2019_ST0006_471_15_20190429_00016.jpg

LM Start	0.00	Rating **	U	Issue No.	15
LM End	0.42	Issue Type +	Ma	Location *	WS
Category	Earthen Levee			GPS Latitude/Longitude	
				Start	End
Item	Vegetation			38.887114 °	38.881287 °
				-121.614739 °	-121.614490 °
DWR ID	DWR_ST0006_01_f_2015_15				
Comment Code					
V1 : Control annual grass and weeds on the levee slopes and easements.					
Inspector Comment					
Remove the annual vegetation and wild growth, Spring 2019.

View looking downstream waterside at the annual vegetation and wild growth that needs to be maintained, Spring 2019.

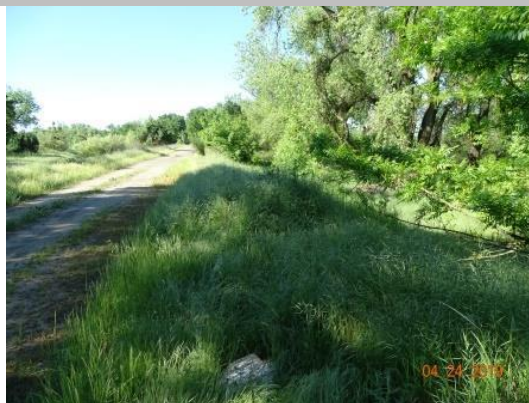
Photo 1 of 1 : SP_2019_ST0006_471_2_20190429_00015.jpg

LM Start	0.00	Rating **	U	Issue No.	2
LM End	0.46	Issue Type +	Ma	Location *	LS
Category	Earthen Levee			GPS Latitude/Longitude	
				Start	End
Item	Vegetation			38.887113 °	38.880833 °
				-121.614739 °	-121.614387 °
DWR ID	DWR_ST0006_01_f_2015_2				
Comment Code					
V1 : Control annual grass and weeds on the levee slopes and easements.					
Inspector Comment					
Remove the annual vegetation and wild growth, Spring 2019.

View looking downstream landside at the annual vegetation and wild growth that needs to be maintained, Spring 2019.

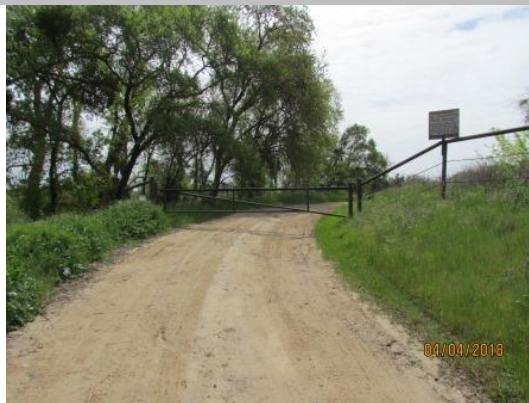
Photo 1 of 1 : SP_2019_ST0006_471_7_20190305_00007.jpg

LM Start	0.00	Rating **	U	Issue No.	7
LM End	0.00	Issue Type +	En	Location *	CR
Category	Earthen Levee			GPS Latitude/Longitude	
				Start	End
Item	Encroachments			38.887059 °	38.887059 °
				-121.614715 °	-121.614715 °
DWR ID	DWR_ST0006_01_f_2012_7				
Comment Code					
FE : Fence					
Inspector Comment					
A landowner has constructed a gate on the crown that hinders inspection of this unit. Met with landowner to perform spring 2015 inspection, and he should be contacted to open the gate for future inspections. The land owner is David Lowry his phone number is (925) 606-2403. He will open the gate for inspections but will not allow the LMA to put a lock on the gate, and the LMA does not do any maintenance to this levee.

View of fence and gate at the upstream end of the levee, only the land owner has the key for the lock on the gate.

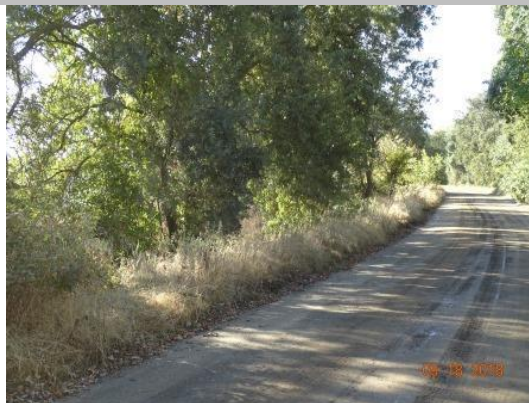
Photo 1 of 1 : SP_2019_ST0006_471_1_20190305_00001.jpg

LM Start	0.13	Rating **	U	Issue No.	1
LM End	0.50	Issue Type +	Ma	Location *	WS
Category	Earthen Levee			GPS Latitude/Longitude	
				Start	End
Item	Trim / Thin Trees			38.885396°	38.880295°
				-121.615595°	-121.614147°
DWR ID	DWR_ST0006_01_f_2017_1				
Comment Code					
T3 : Trim and thin trees to allow visibility of the ground and room to flood fight.					
Inspector Comment					
Trim up the trees to 5 feet above the ground for access and visibility, Spring 2019.

View looking downstream waterside of the over growth of trees.

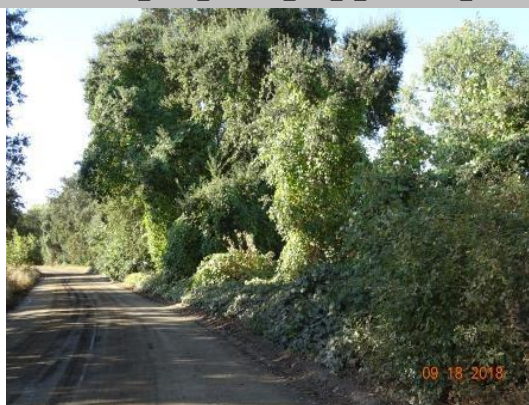
Photo 1 of 1 : SP_2019_ST0006_471_3_20190305_00005.jpg

LM Start	0.13	Rating **	U	Issue No.	3
LM End	0.50	Issue Type +	Ma	Location *	LS
Category	Earthen Levee			GPS Latitude/Longitude	
				Start	End
Item	Trim / Thin Trees			38.885396 °	38.880295 °
				-121.615595 °	-121.614147 °
DWR ID	DWR_ST0006_01_f_2017_3				
Comment Code					
T3 : Trim and thin trees to allow visibility of the ground and room to flood fight.					
Inspector Comment					
Trim up the trees to 5 feet above the ground for access and visibility, Spring 2019.

View looking downstream landside of the over growth of trees.

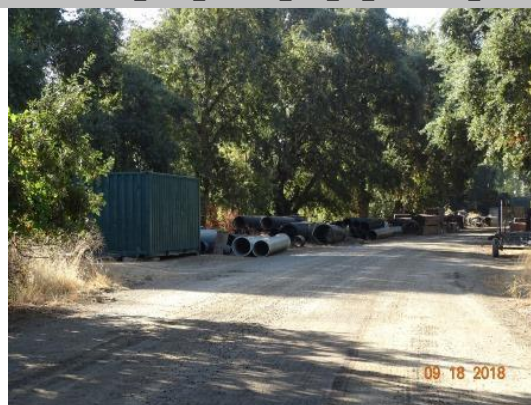
Photo 1 of 1 : SP_2019_ST0006_471_16_20190305_00012.jpg

LM Start	0.40	Rating **	U	Issue No.	16
LM End	0.46	Issue Type +	En	Location *	WS
Category	Earthen Levee			GPS Latitude/Longitude	
				Start	End
Item	Encroachments			38.881638 °	38.880795 °
				-121.614647 °	-121.614427 °
DWR ID	DWR_ST0006_01_f_2015_16				
Comment Code					
DE : Debris					
Inspector Comment					
The large pipe is still laying along the waterside berm, Spring 2019.

View of the pipes and new c-container along the waterside shoulder looking downstream.

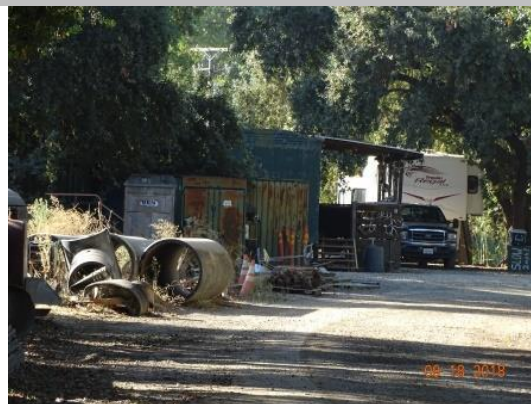
Photo 1 of 1 : SP_2019_ST0006_471_8_20190305_00008.jpg

LM Start	0.47	Rating **	U	Issue No.	8
LM End	0.47	Issue Type +	En	Location *	CR
Category	Earthen Levee			GPS Latitude/Longitude	
				Start	End
Item	Encroachments			38.880664 °	38.880664 °
				-121.614335 °	-121.614335 °
DWR ID	DWR_ST0006_01_s_2012_8				
Comment Code					
BU : Building					
Inspector Comment					
The building is directly behind the pipes that are laying along the waterside berm. Spring 2019.

View of the building directly behind the pipes on the waterside berm looking downstream.
